# Manhole Inspection Summary

Manhole # S45C2\_002MH

Insp Date: **11/29/08 3:10 PM**

**Location** Address: **3601 Fairhaven Ave.**

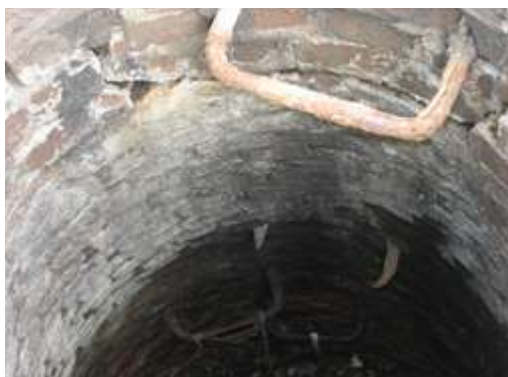
step

Count: **4** Missing: **0** ☒ **Corroded**

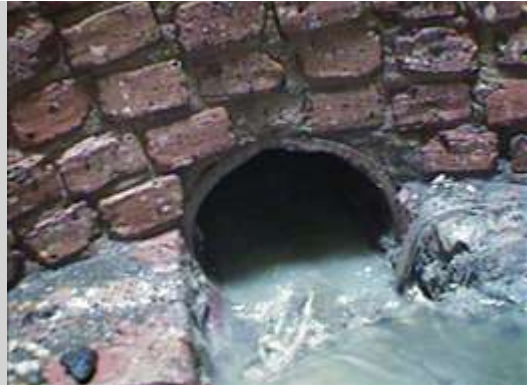
12 O'Clock Outflow

10 in. Circular Gravity Sewer  
Pipe Out @ 12 O'Clock

Pipe Height: **12** (in.) Rod and Bar (Angled)  
Pipe Material: **Clay** ☐ Pipe Lined  
Invert Depth: **9.60** (ft.) Flow Characteristics: **Slow**  
Deposits: ☐ None ☐ Mud ☐ Sludge ☒ **Debris** ☐ Grease  
Silt Depth: **1** (in.) Deposits Extent: **Light**  
Infiltration: **None** Pipe Seal Cond: **Sound**

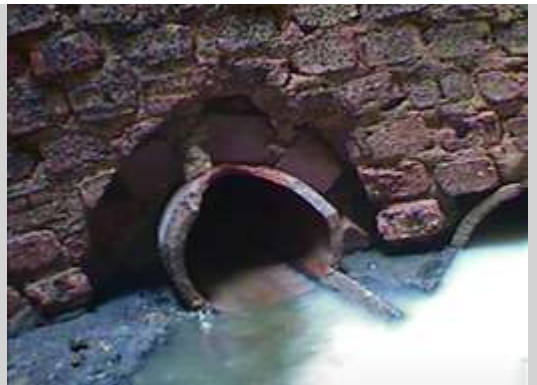
2 O'Clock Inflow

8 in. Circular Gravity Sewer  
Pipe In @ 2 O'Clock

Pipe Height: **9.6** (in.) Rod and Bar (Angled)  
Pipe Material: **Clay** ☐ Pipe Lined  
Invert Depth: **9.15** (ft.) Flow Characteristics: **Slow**  
Deposits: ☐ None ☒ **Mud** ☐ Sludge ☐ Debris ☐ Grease  
Silt Depth: **0** (in.) Deposits Extent: **Light**  
Infiltration: **None** Pipe Seal Cond: **Cracked**

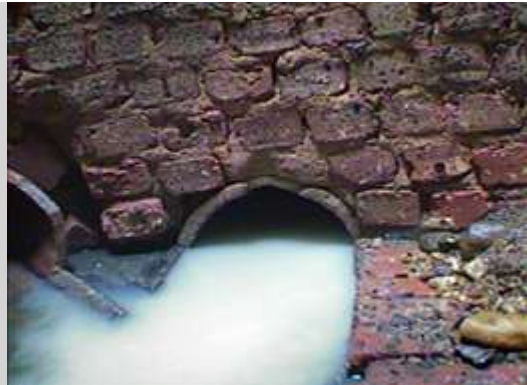
4 O'Clock Inflow

10 in. Circular Gravity Sewer  
Pipe In @ 4 O'Clock

Deposits: ☒ None ☐ Mud ☐ Sludge ☐ Debris ☐ Grease

Infiltration: **None** Pipe Seal Cond: **Sound**
